CAMPUS DEVELOPMENT PLAN

Central Oregon Community College

JUNE 1990

**W.E. GROUP Architects and Planners
Portland, Oregon**

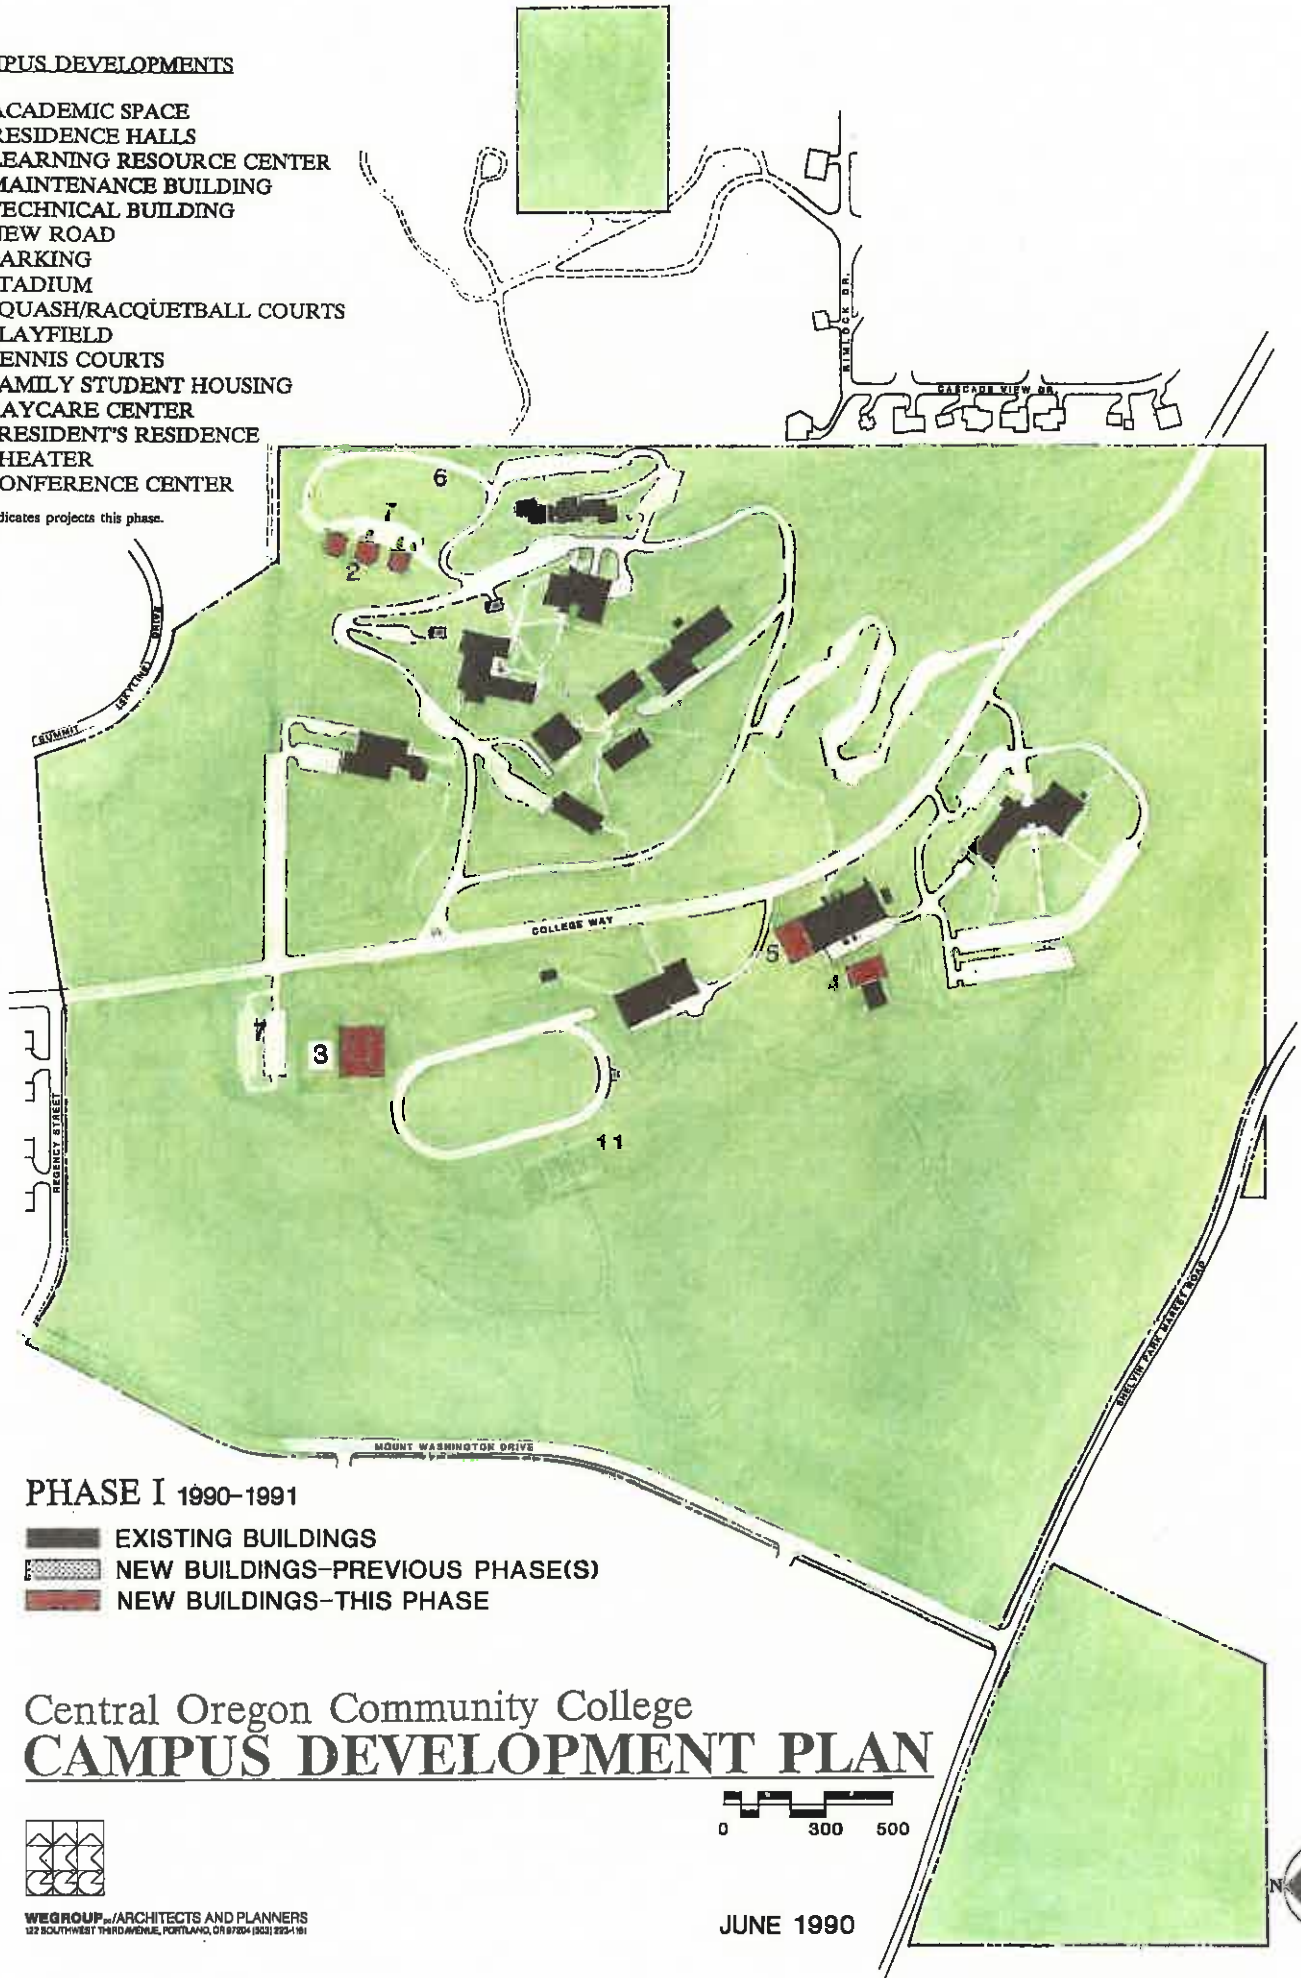
PHASE I 1990-1991

- EXISTING BUILDINGS
- ▨ NEW BUILDINGS- PREVIOUS PHASE(S)
- NEW BUILDINGS- THIS PHASE

- * 1. ACADEMIC SPACE
- * 2. RESIDENCE HALLS
- 3. LEARNING RESOURCE CENTER
- 4. MAINTENANCE BUILDING
- 5. TECHNICAL BUILDING
- * 6. NEW ROAD
- * 7. PARKING
- 8. STADIUM
- 9. SQUASH/RACQUETBALL COURTS
- 10. PLAYFIELD
- 11. TENNIS COURTS
- 12. FAMILY STUDENT HOUSING
- 13. DAYCARE CENTER
- 14. PRESIDENT'S RESIDENCE
- 15. THEATER
- 16. CONFERENCE CENTER
- * 17. PAR COURSE

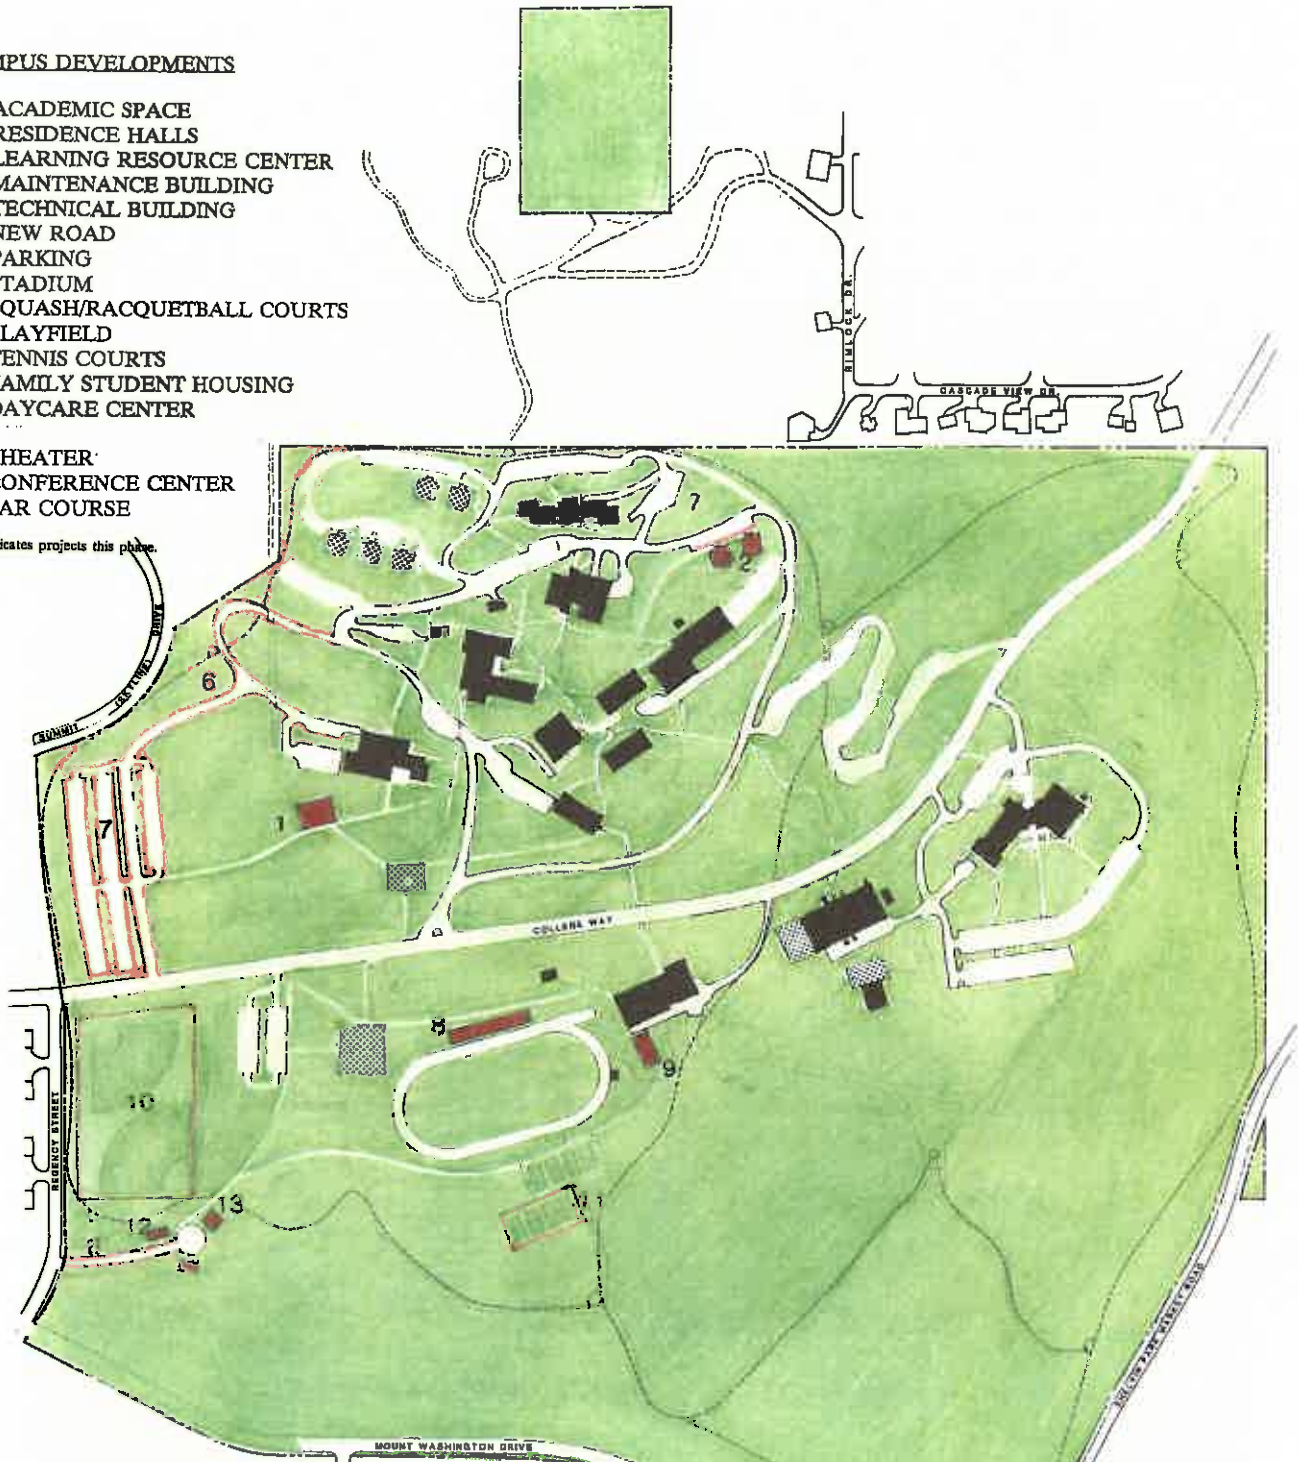
PHASE III 1995-1997

- EXISTING BUILDINGS
- NEW BUILDINGS-PREVIOUS PHASE(S)
- NEW BUILDINGS-THIS PHASE

- * 1. ACADEMIC SPACE
- * 2. RESIDENCE HALLS
- 3. LEARNING RESOURCE CENTER
- 4. MAINTENANCE BUILDING
- 5. TECHNICAL BUILDING
- 6. NEW ROAD
- 7. PARKING
- 8. STADIUM
- 9. SQUASH/RACQUETBALL COURTS
- 10. PLAYFIELD
- 11. TENNIS COURTS
- * 12. FAMILY STUDENT HOUSING
- 13. DAYCARE CENTER
- * 14. PRESIDENT'S RESIDENCE
- * 15. THEATER
- * 16. CONFERENCE CENTER
- 17. PAR COURSE
